PRELIMINARY ASSESSMENT REPORT
For
SBA SHIPYARD
JENNINGS, JEFFERSON DAVIS PARISH, LOUISIANA

Prepared for
U.S. Environmental Protection Agency Region 6
1445 Ross Avenue
Dallas, Texas 75202

June 3, 2013

Prepared by
Dynamac Corporation
1323 Columbia Drive, Suite 307
Richardson, Texas 75081
(214) 575-3344

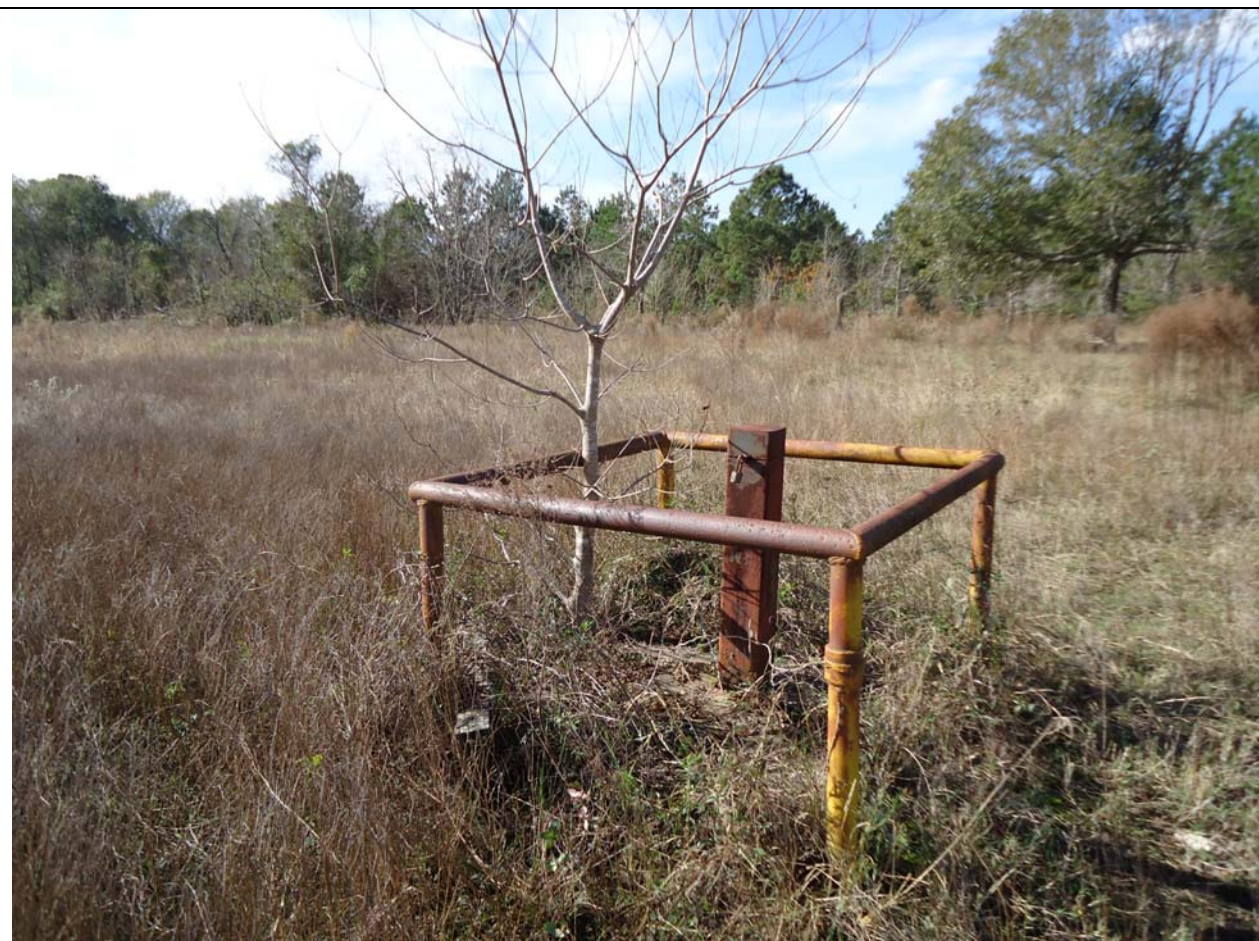
Logbook Photo #	DSC00129
US EPA CERCLIS No / Task Order Number	LAD008434185 / TO-0009-12-10-02
Site	SBA Shipyard
Location Address	9040 Castex Landing Road
City, State	Jennings, Louisiana 70546
Parish	Jefferson Davis
Direction/Orientation	South
Date	12/11/12
Time	1030
Photographer	K. Lloyd (START)
Witness	N. Biscocho (START)
Description: Monitor Well 4 (zoom out)
